Why did Palau Bridge collapse?

Koror-Babelthaup Bridge

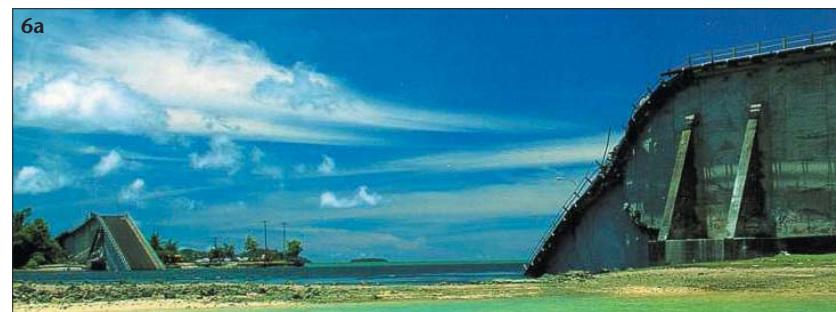
- Removal of the central hinge to make the structure continuous
- Installation of eight additional, external, post-tensioned prestressing cables inside the box section, running beneath the top slab near the main pier and, via two deviator beams on each side, moving to the bottom of the box near the centre. All these additional tendons were continuous through the bridge, being anchored between the piers on each side. 36MN of force was applied to these cables, creating a hogging central moment intended to remove 0.3m of the deflection.

- Insertion of eight flat-jacks between the top slabs, in place of the central hinge, which were used to apply an additional 31MN of longitudinal compressive force. These were grouted in place, making the span continuous. The combined effect of the external cables and flat-jacks will be referred to here as the additional prestress. The decision to make the bridge continuous was a late amendment to the design, and apparently taken on economic grounds since it allowed the new cables to pass from one half-span to the other and thus halved the number of anchorages required.

- Replacement of the bridge surface throughout. Because the prestress would not eliminate all the sag, a lightweight void former was to be inserted over the central area under the new surface, to provide a smooth running surface.

Fig 5. (left)
Key features of
original structural
design and
alterations made
during remedial
works

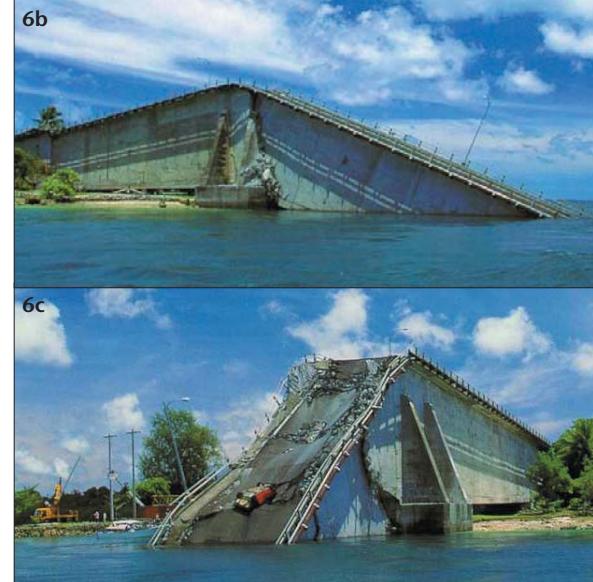
Fig 6. (above & right)
Photos showing the
bridge after the
collapse²²

- (a) the whole span viewed from the Babelthuap side
 - (b) Koror side (West)
 - (c) Babelthuap side (East)
- (photo: © William E. Perryclear)

4. The resulting compressive stresses just east of the Koror main pier caused the base of the box girder to crush and displace into the pier itself. The top slab then failed in tension, the backspan fell to the ground and the central span dropped into the channel.

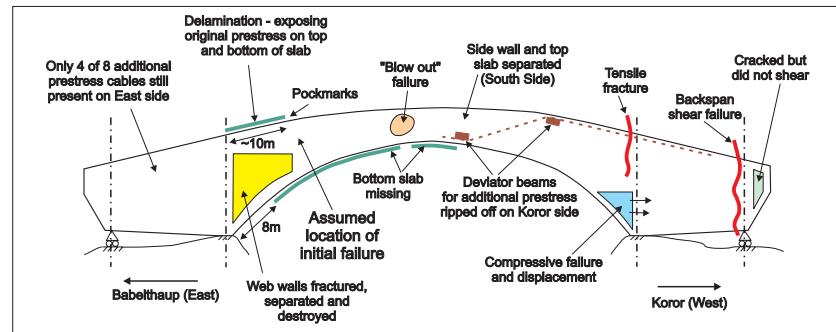
1. Delamination of the top flange occurred near the main pier on the Babelthuap side. This 'rendered it incapable of providing resistance against the original post-tensioning forces ... causing the rest of the girder to behave as a reinforced concrete girder spanning between the [centre] and the [Babelthuap] main pier'.
2. Large hogging moments resulted over the main pier, inducing far greater tensile stresses in the top slab and upper region of the webs than could be sustained. The webs therefore failed at the top, resulting in near total loss of their shear capacity. As a result, the Babelthuap side of the span failed in shear, next to the main pier.
3. The weight of both halves of the main span therefore acted on

Fig 7.
Damage to the
bridge, as reported
by SSFM after the
collapse^{8,13}. Sketch
only, not to scale

the Koror side. Unable to sustain this increased load, the remainder of the bridge rotated around the Koror-side main pier, shearing the backspan just east of the end pier and lifting it temporarily into the air.

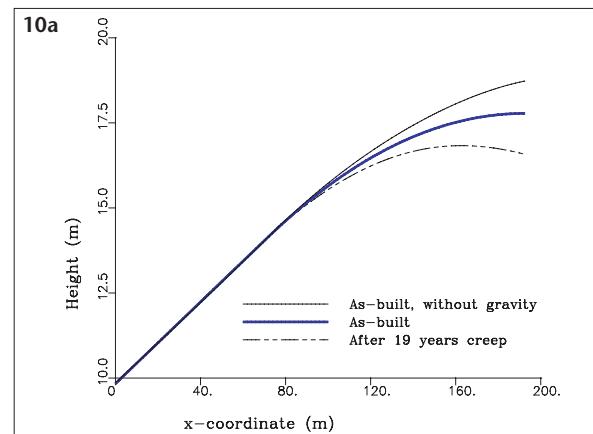
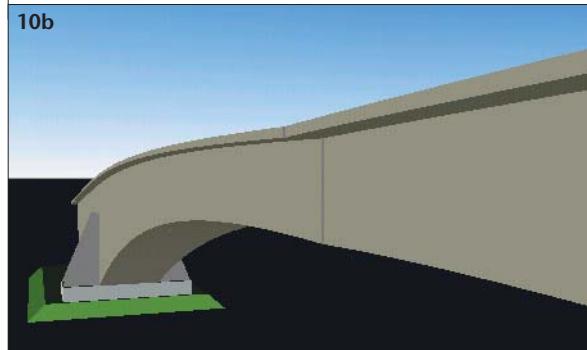
If the concrete had a short-term Young's modulus (E) when cast of 30kN/mm^2 (which may be a little high), the tip deflection due to the beam's own self-weight would have been 0.95m . By assuming a creep factor φ , so that the effective modulus becomes $E/(1 + \varphi)$, the observed creep deflection at the tip of 1.2m would have been produced by $\varphi = 1.26$; this is based on creep affecting the concrete alone and does not take into account the untensioned reinforcement and the reduction of prestress due to creep. These values seem reasonable (although E should perhaps have been lower and φ higher), and the observed deflection due to creep should have been predictable. Fig 10(a) shows the profile of the top chord both as-built, and after 19 years of creep. The vertical scale is exaggerated but the kink that would occur at the centre is clearly visible. The top line shows the assumed profile of the bridge with the dead load removed; it is assumed that the bridge was built so that when complete it reached the desired alignment. The virtual reality image in Fig 10(b) shows, to scale, the kink at mid-span.

Fig 10.
(a) Top chord profile
of bridge
(b) VR model at mid-
span, showing
effects of creep

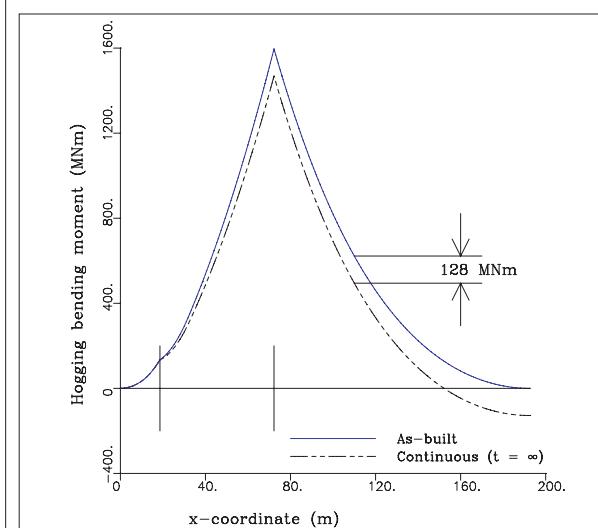
Fig 11 shows the as-built bending moment diagram due to the bridge's own dead weight for one cantilever, as a solid line. There is, of course, no question about these values since the structure was at that stage still statically determinate. The plotted values include the effect of the ballast in the back-span, since this is a permanent load. The ballast was sufficient to ensure a compressive reaction at the end pier, which nevertheless was provided with a tie-down. The peak moment at the main support is 1596MNm, while at $x = 86 \text{ m}$ the moment is 1165MNm and the shear force 27.9MN.

Fig 11.
Dead-weight
bending moment
diagram, including
ballast

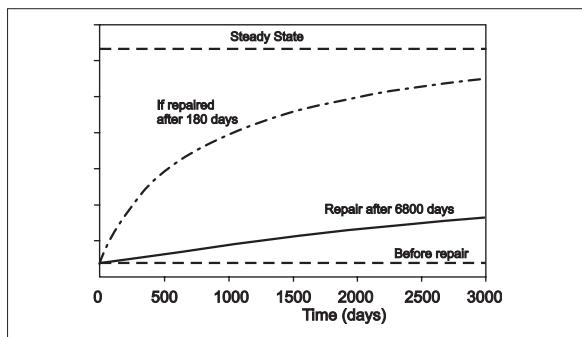
Fig 12.
Change in support reaction with time due to thermal creep

The chain-dashed line shows what would have happened if the structure had been made continuous only 6 months after completion. Even then, the relatively old concrete in the main cantilevers would have slowed-down the creep effects caused by making the structure continuous, and after 3000 days (over 8 years), the change in moment has still only moved 80% of the way to its ultimate value.

The solid line shows the situation to be expected when the structure was made continuous after nearly 19 years, as actually happened. The structure does still creep towards the same asymptote, but much more slowly. The change in the 90 days between repair and collapse is only about 1% of the full amount and can thus be sensibly ignored. It can be concluded that there was insufficient time between repair and failure for the creep to have had any significant effect on the overall distribution of bending moments.

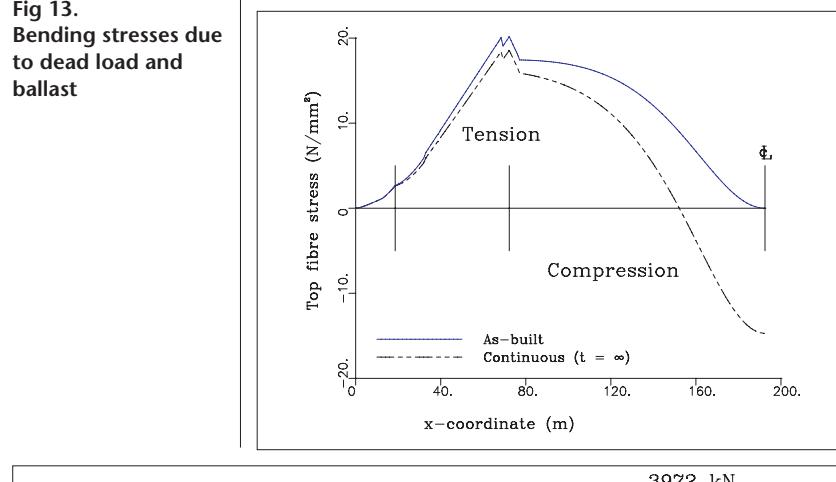
Even if these creep effects had occurred, it is doubtful that they would have caused any problems. The effect of the bending moments (from Fig 11) on the top fibre stresses is shown in Fig 13; no account is taken here of any prestress. The as-built stresses are tensile (+ve) everywhere. The reduced inertia at the tip of the cantilever means that the sagging continuity moment has a relatively large effect on the stress near the centreline. The values shown in the figure are for the top fibre, and are thus compressive at the centreline, but there are corresponding tensile stresses in the bottom flange. As far as is known, no continuity steel was placed across the joint when the structure was made continuous, and the additional prestress that was added (to be discussed below), was placed in the top flange.

Thus, it must be expected that these stresses, even if they did get induced in the bridge by creep, would have caused the new continuity joint to open up at the bottom because there was nothing to resist the tension. This would have restored the structure to its original configuration of two independent cantilevers.

Fig 13.
Bending stresses due to dead load and ballast

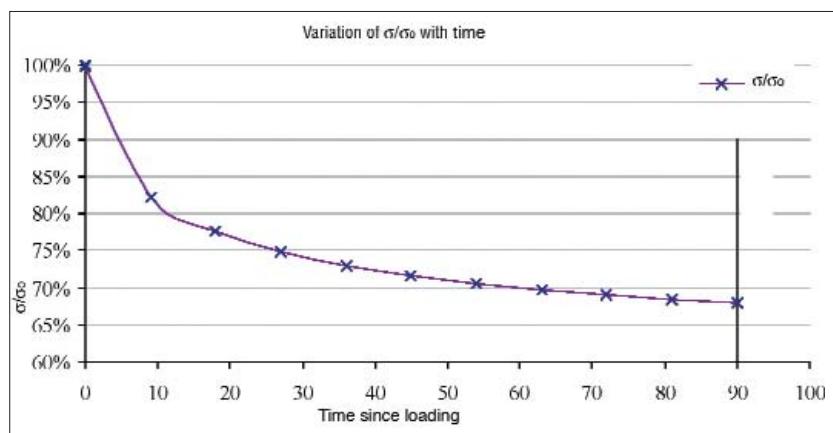
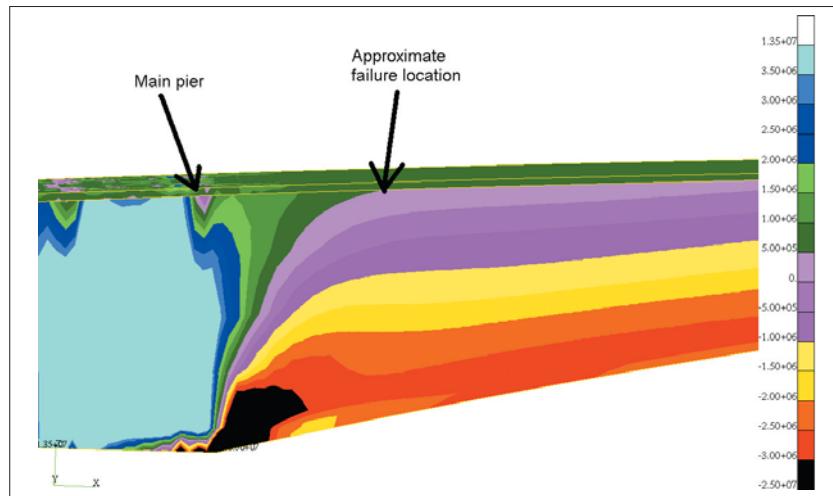
Fig 18. (below)
Effect of creep in the
in situ joint on the
stress due to the flat
jacks
Fig 19. (bottom)
Vertical shear stress
in web near failure
location, varying
from -3MPa at base
to 0.5MPa at top
