A reconsideration of the safety of piled bridge foundations in liquefiable soils

S. Bhattacharya, S.P.G. Madabhushi, M.D. Bolton, S.K. Haigh and K. Soga

Cambridge Geotechnical Research Group, Schofield Centre, University of Cambridge (U.K).

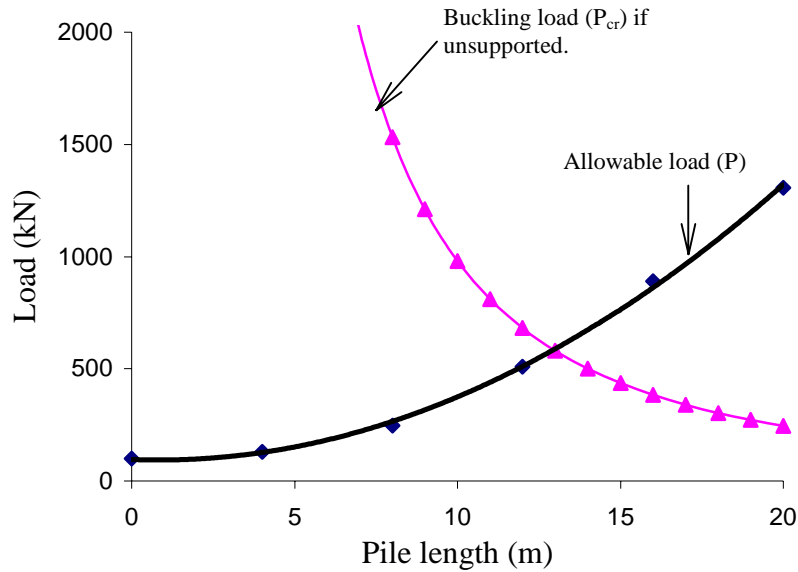
Fig. 2: Allowable load and buckling load (if unsupported) of a typical pile.

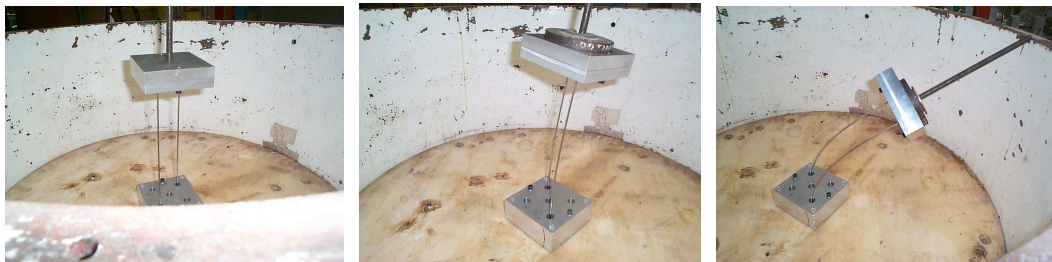
Figure 3: Instability test with slender columns.

Length of the pile in liquefiable zone is 10m and the length of pile in free air/water is 9m. Thus pile in unsupported zone during liquefaction is 19m. From the buckled shape (shown as original position in Figure 19, it is clear that the pile had fixed-free boundary condition and hence the effective length is twice the length in unsupported zone. It is also in some way similar to the shape as observed in Figure 3.

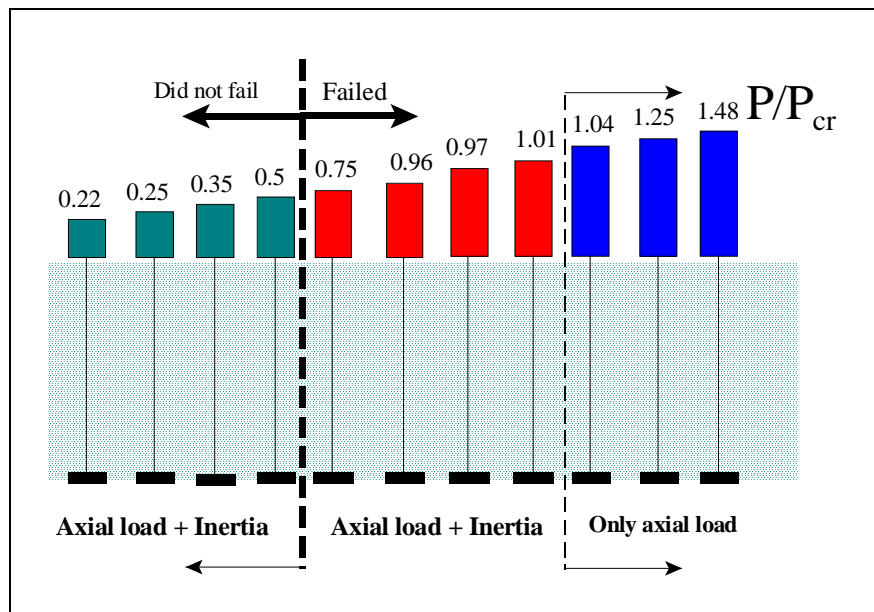
Figure 8: Schematic representation of the test results.

Figure 8 summarises the performance of the piles along with the load effects acting. Emphasis is given to the normalised axial load (P/P_{cr}) where P is applied axial load or the axial load at failure. The piles marked 7 and 8 in test SB-04 (Table 2) were tested in similar conditions (in test SB-05, not included in Table 2) but in the absence of soil which simulated Euler’s classical buckling. Thus, through the series of tests the various influences on pile behaviour could be distinguished. Details of all these tests can be seen in Bhattacharya et al (2002, 2003), Bhattacharya (2003).

As can be seen from Table 2 and Figure 8, axial load applied to the piles ranged from 22% to 148% of Euler’s elastic critical load (P_{cr}) treating piles as long columns neglecting any support from the soil. From the repeatability of the observations, it immediately becomes obvious from the table that the piles having P/P_{cr} ratio greater than 0.75 failed. This result is consistent with the study of case histories where the piles that failed had (P/P_{cr}) ratio between 0.5 and 1 (see Figure 6).

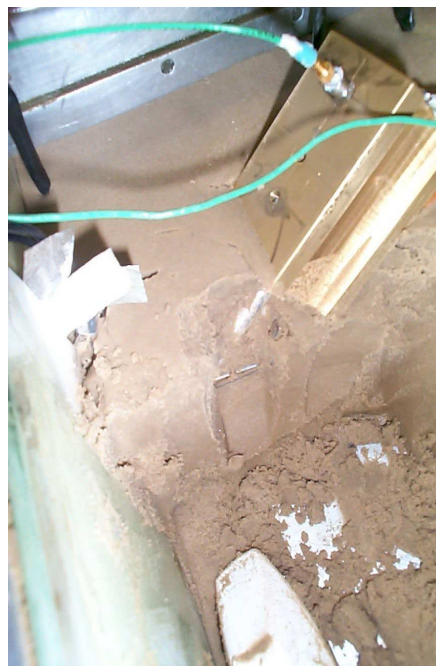
Figure 11: Mode shape of pile 10 after the test during excavation

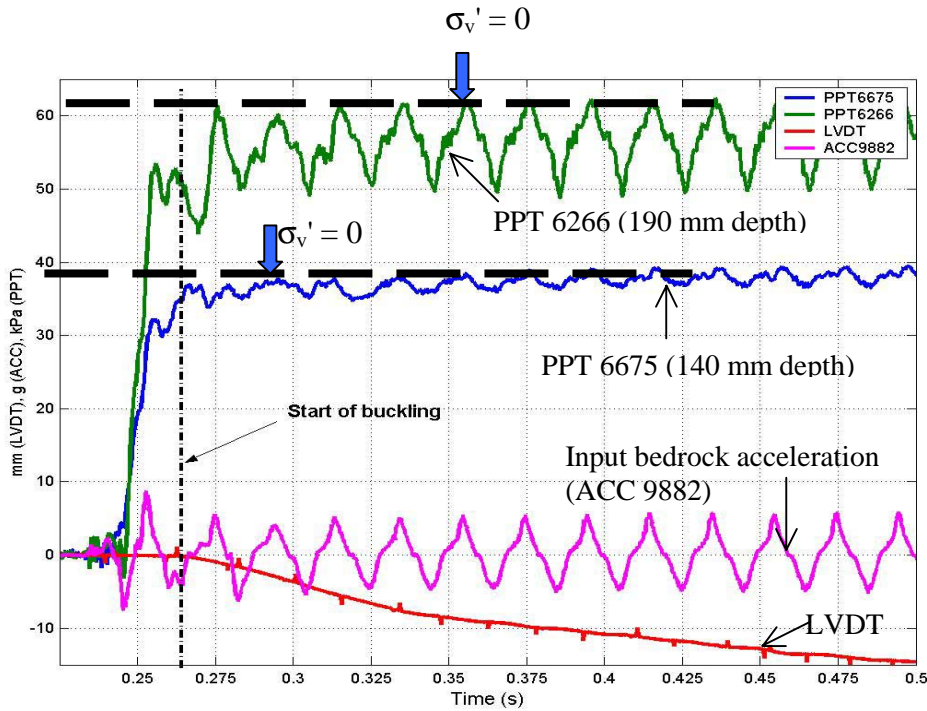
Figure 12: Time histories of input acceleration, pore pressure and LVDT reading for pile 10.

Figure 12 plots the time histories of input acceleration, pore pressure records and the LVDT readings. It may be noted that from the PPT records that as shaking starts (0.22s in the time history) pore pressures begin to rise. The LVDT record on the other hand shows that the pile starts to move unidirectionally at around 0.26s in the time history i.e. after two full cycles of loading. It must also be remembered that this unidirectional movement is orthogonal to the direction of shaking and thus denotes the onset of buckling instability. This confirms that the buckling is not linked to inertia. It

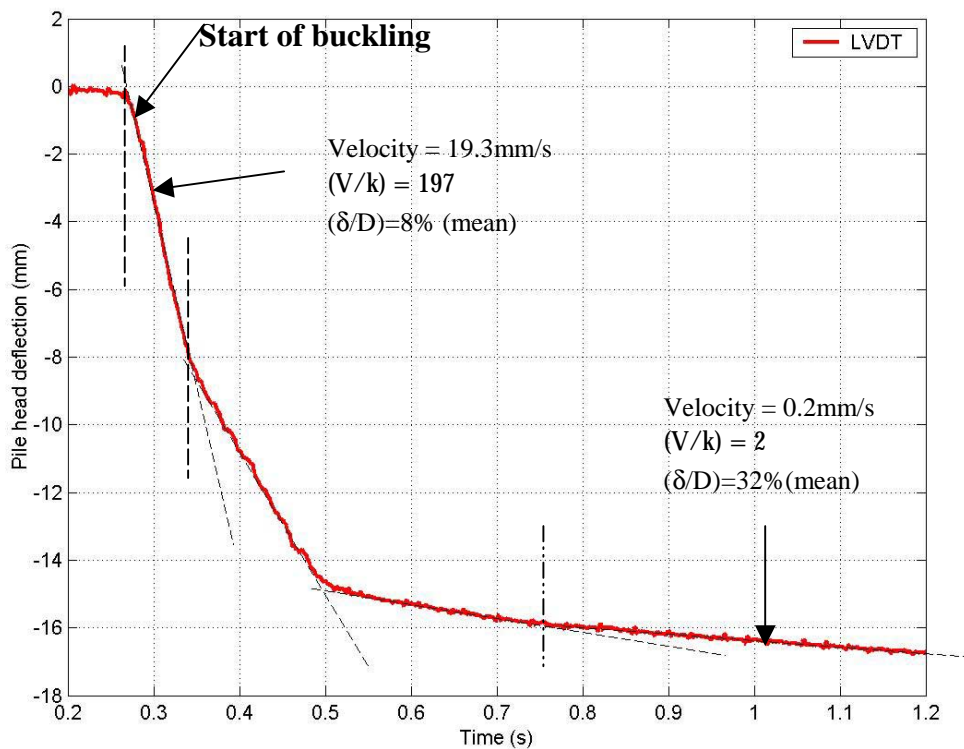
Figure 13: Displacement record of the LVDT in Figure 9

Figure 13 replots the time history of the LVDT record. It can be noted that the gradient of the displacement decreases with the progression of pile movement i.e. buckling. In other words, the pile is having negative acceleration or deceleration and the opposing force must be the resistance of the liquefied soil. In the plot, three parameters are shown in the text boxes for the time intervals at the beginning and end of the buckling of the pile. The values correspond to the level of the pressure cells i.e. at 75mm depth. The parameters are:

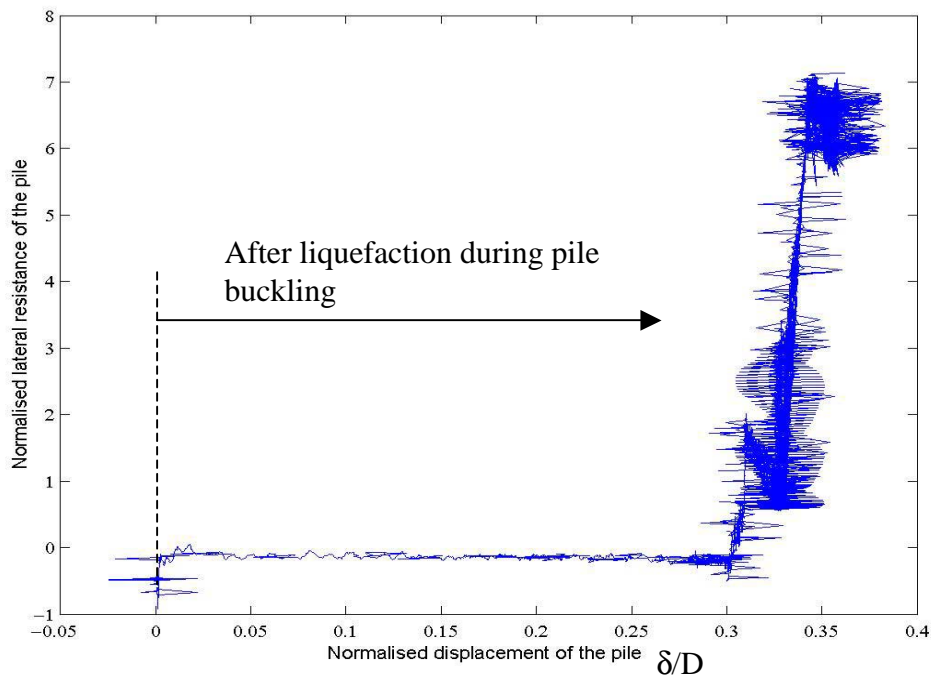
Figure 14: Normalised lateral resistance versus normalised lateral displacement (δ/D).

The difference in the stress cells (SC2 and SC3 in Figure 9) readings approximately measures the lateral resistance offered by the liquefied soil to the buckling pile. The lateral resistance measured is normalised by the initial over burden pressure (33.3kPa) at the level of the pressure cells. Figure 14 shows the plot of normalised lateral resistance with the normalised displacement of the pile (δ/D). It may be noted that lateral resistance increases drastically after 30% of reference strain, which also substantiates the LVDT record. It has been shown by Bhattacharya et al (2002, 2003) that the liquefied soil offers resistance and dictates the hinge formation but cannot prevent the initiation of buckling.

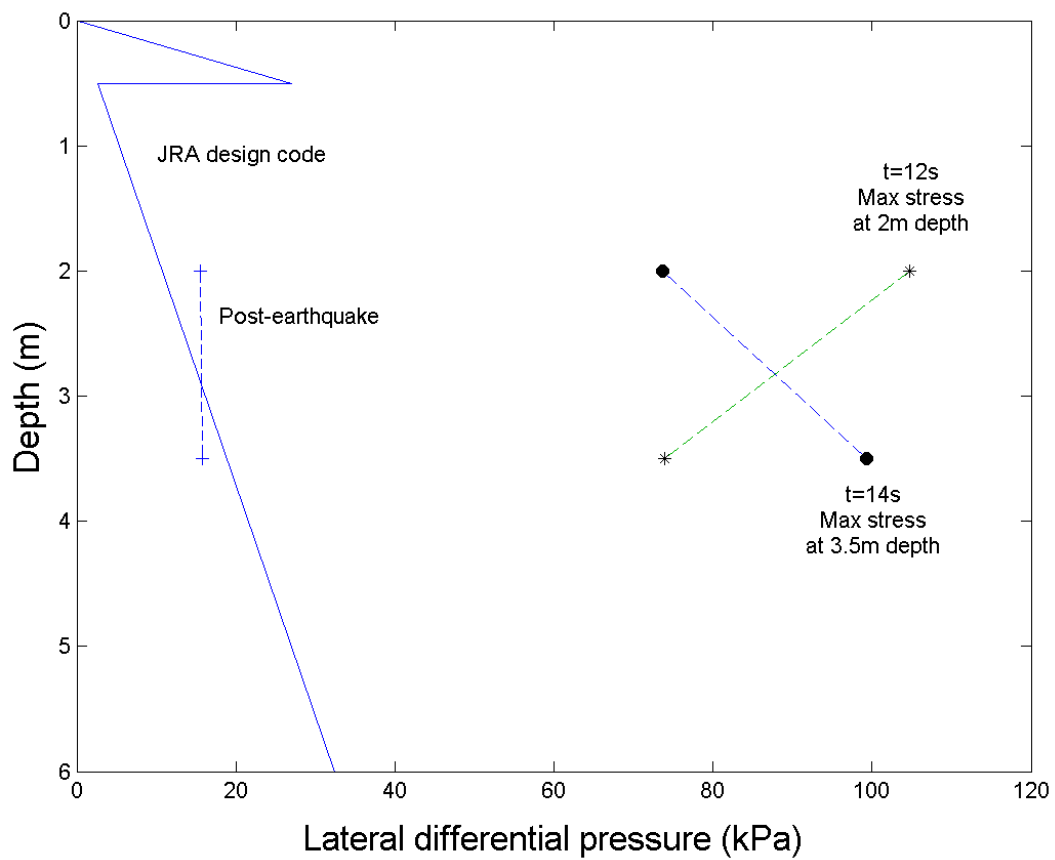
Figure 16: Downslope pressures measured on pile in comparison to those from the JRA code.

Dynamic centrifuge model tests have been carried out at Cambridge in which piles with no axial load were placed in laterally spreading slopes, (Haigh, 2002). Instrumentation was in place near to the upslope and downslope faces of these piles in order to measure the lateral total and effective stresses exerted on the piles. Time histories of the differences between the pressures acting on the front and back faces of the pile at the same depth were calculated and showed that significant downslope lateral pressures were exerted on the piles by the laterally spreading ground, as is seen in Figure 15. A summary of the peak lateral stresses measured as acting on the faces of the pile is shown in Figure 16 together with the design loads calculated from the JRA code. The peak stresses at the two depths (2.5 m and 3.25 m) do not occur simultaneously, hence the two lines for maximum loading conditions shown in the figure. It can be seen that the peak applied transient loading exceeds that predicted by the code by a factor of approximately three, whereas post-earthquake residual flow loading is very similar to that predicted by the code.

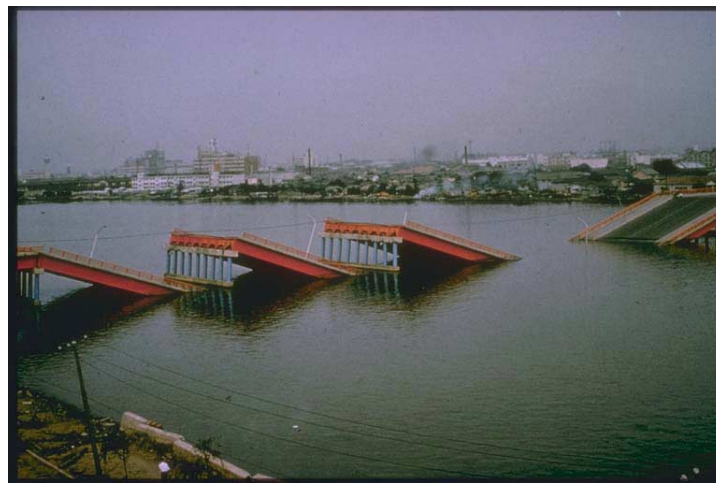
Figure 17: Failure of Showa Bridge.

The bridge was built over river Shinano and was completed just a month before the earthquake (Fukoka, 1966). The bridge had a width of 24m and total length of 303.9m. The superstructure of the bridge consisted of 12 composite girders. The foundations of each pier consisted of a row of 9 steel tubular piles connected laterally as shown in Figure 17. After the earthquake five girders (G_3 to G_7) fell into the river as shown in Figure 18. Figure 19 shows the post earthquake failure

The photographs (Figures 17 and 18) show that the failed piles were fully submerged in water and hence a non-liquefied crust is unlikely to exist. Figure 20 shows the loading diagram based on the JRA code. The calculation below estimates the maximum moment based on JRA code.

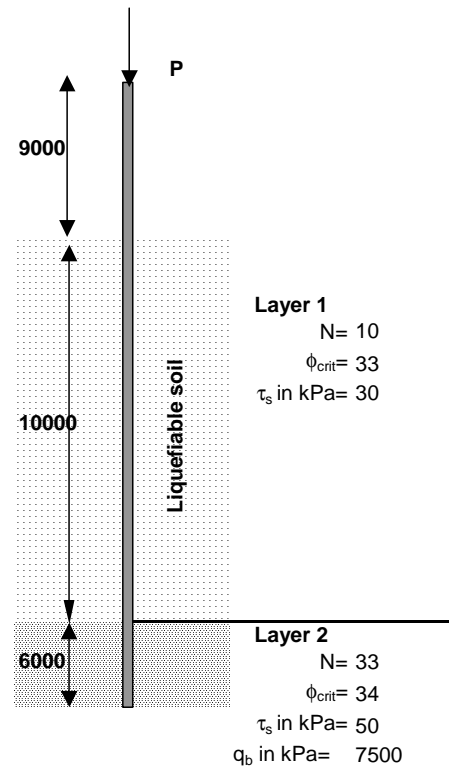
Figure 21: Design data to estimate the conventional pile capacity.

Earthquake-induced shaking caused the pore pressures to build up in the loose saturated sandy soil, and the soil started to liquefy. The piles lost their shaft resistance in the liquefiable region (layer 1 in Figure 21) and transferred the loads downwards to layer 2 with minor settlements. The soil liquefied and therefore lost its stiffness causing the pile to act temporarily as an unsupported column. The pile became elastically unstable and began to move sideways in the direction of least elastic stiffness, shearing the soil next to it. The initial resistance to the movement of the pile offered by the liquefied soil will be negligible but a large undrained shear resistance can be mobilised after a certain amount of monotonic displacement. The undrained resistance of initially liquefied soil is caused by negative excess pore water pressures, due to suppressed dilation, in the shear zone and depends on the velocity of buckling as observed by Takahashi et al. (2002) and discussed in the earlier section of the paper. This dilatant sand can hold a buckling pile in quasi-static equilibrium.
