BEHAVIOUR OF RIGID FOUNDATION ON HOMOGENEOUS LOOSE SOIL

Data report on tests BG-01 to BG-03 Barnali Ghosh & S.P.G. Madabhushi CUED/D-SOILS/TR-330

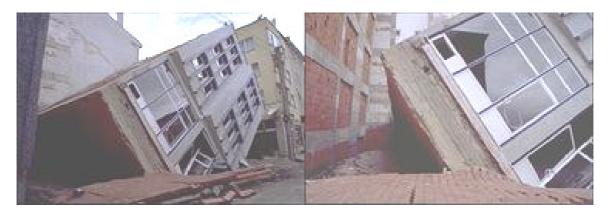
Figure 1: Liquefaction induced bearing capacity failure in the Kocaeli earthquake (Photo courtesy NISEE website, University of California, Berkeley).

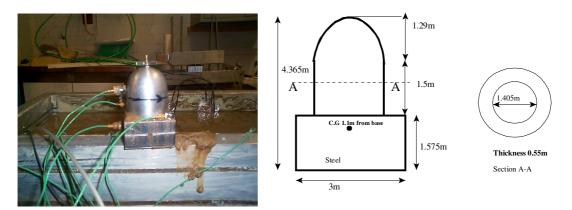
Table 2 shows the structural properties of the different materials used in designing the model structure. The embedded raft foundation plate made from steel and the dome was made of dural (aluminium alloy). The total bearing pressure was 148 kPa at 50g. Figure 2 shows the model structure with its foundation. The superstructure is very rigid having a very low natural time period. The h/r ratio for the building is 1.65 where h is the height of the containment and r is the effective radius for an equivalent circular foundation. Such low value of h/r suggests that rocking during seismic shaking is unlikely and horizontal mode of vibration will dominate.

Figure 2: Model structure and its dimension in prototype scale.

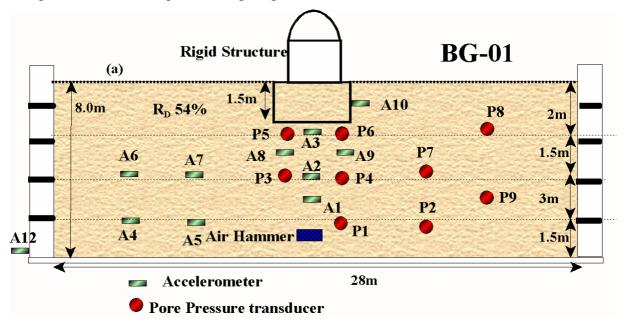
Figure 3: Instrumentation and test layout of BG-01.

Figure 3 and 4 presents the instrumentation layout at prototype scale for tests BG-01 and BG-02. The general instrument location was motivated by the fact that there should be a dense array of instrumentation close to the structure. The instrumentation in these tests consisted of accelerometers, pore pressure transducers and LVDT's. The initial models were essentially loose to medium relative density sand, which was expected to liquefy under medium and strong earthquakes. Table 3 presents the instrument locations in prototype scale.

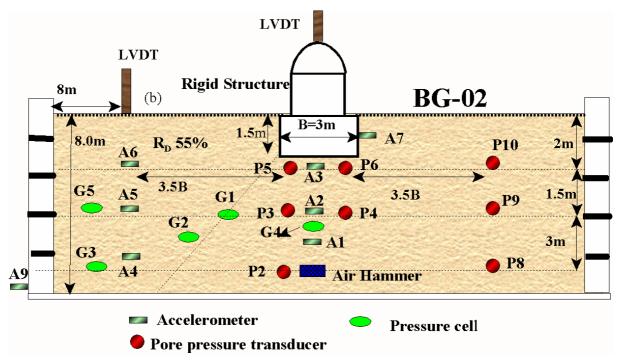
Figure 4: Instrumentation and test layout of BG-02.

In BG-02 attempts were made to measure the vertical pressure using earth pressure cells. As reported by several investigators (Clayton et al. 1993), it is extremely difficult to measure total stress in soil, so the results have to be viewed with caution. The pressure cells were arranged in such a way that they were coincident with the assumed load dispersion lines obtained from elastic solutions. Special care was taken of the earth pressure transducers that were buried in the liquefiable saturated sand.

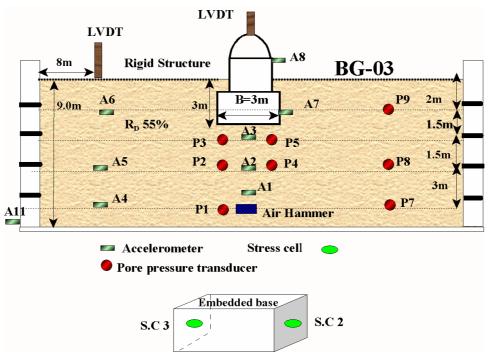
Figure 5: Instrumentation and test layout for test BG-03; Stress cell 4 and 5 are underneath the base of the raft foundation.

One of the other interests in this tests series was to investigate the effects of embedment on the overall seismic response. The embedment depth was varied in the tests. In BG-03 the embedment was 3m and lateral pressures were measured during the shaking using

earth pressure cells as shown in Figure 5 as the main horizontal interaction force is provided by direct stress on the walls of the foundation. These cells were glued to the edges of the base raft with double-sided tape to secure their positions. A series of earthquakes was fired at 50g for each model. Each shaking event was followed by a stationary period to allow for dissipation of the developed excess pore pressures.
