Why did Palau Bridge collapse?

Koror-Babelthaup Bridge

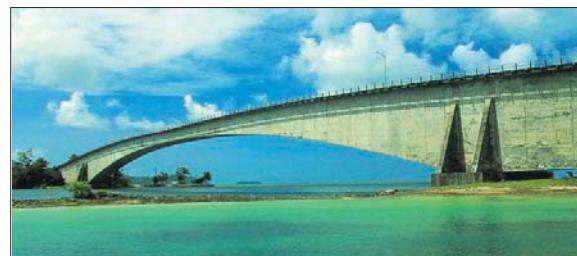
Fig 1. (left)
The Koror-Babelthaup Bridge prior to collapse²²
(photo: © William E. Perryclear)

The bridge cost \$5.2M to build, and was completed in April 1977, after which it remained unchanged for the next 18 years. Over this period the cantilevers deflected due to creep, shrinkage and prestress loss. By 1990 the sag of the centre line had reached 1.2m (visible in Fig 1), affecting the appearance of the bridge, causing discomfort to road users, and damage to the wearing surface. The Palauan government commissioned two teams of experts to assess the safety of the structure and its ability to continue to carry the design loads in the future. Louis Berger International (USA) and the Japan International Cooperation Agency both concluded that the bridge was safe and would remain so, but the deflection could be expected to increase further in the future (by another 0.9m over the next 100 years). As a result, the decision was made to put out to tender remediation works to correct some of the sag and prevent further deflection⁸.

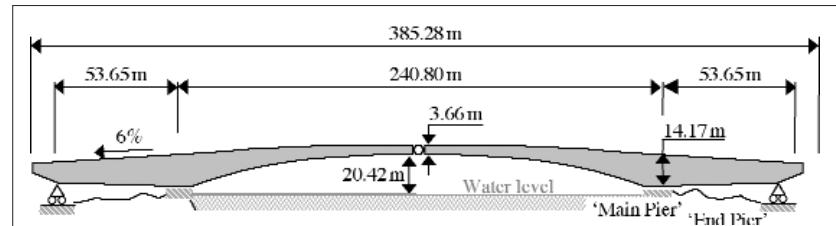
Fig 2. (below)
Elevation showing bridge geometry, as built

The original design was symmetric, each side consisting of a 'main pier' on the channel edge, from which cantilevers extended over the water, meeting in the centre. Outside the main piers were the approach spans, which rested on the 'end piers'. The main pier was supported on inclined piles which resisted horizontal forces, while the end piers had only vertical piles which will be assumed here to provide only a simple support. The cantilevers themselves, which were segmental and cast in place, were joined by a central hinge, intended to carry negligible load but to ensure displacement compatibility across the span. The hinge contained bearings to allow longitudinal movement and rotation of the half-spans relative to one another. An elevation of the original design is sketched in Fig 2. A 'box' cross section was used throughout, with fixed widths but varying depth, as shown in Fig 3.

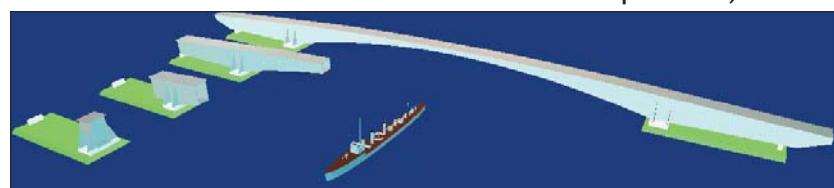
Fig 4. (below)
VR model of original construction sequence
(The model can be downloaded from www-civ.eng.cam.ac.uk/cjb/4d8/public/palau.html)

Each half of the bridge had been built as balanced but unsymmetric cantilevers, working away from the main pier, until the back span reached the end pier (Fig 4). This span was then filled with ballast to provide moment reaction for completion of the cantilevers.

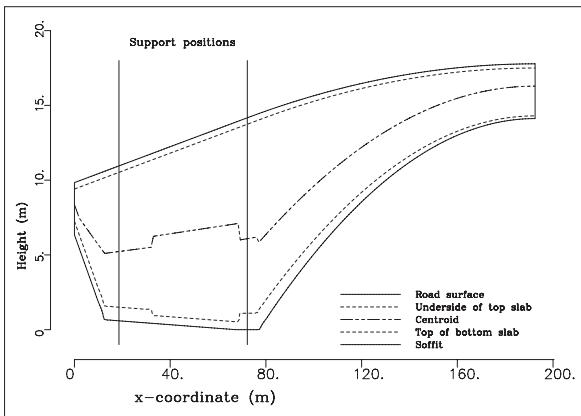
Fig 8. (above)
Geometry as-built.
Vertical scale
exaggerated

The detailed geometry¹¹ of one half of the structure is shown in Fig 8, and the corresponding second moment of area is shown in Fig 9. The x-coordinate used here is measured from the extreme

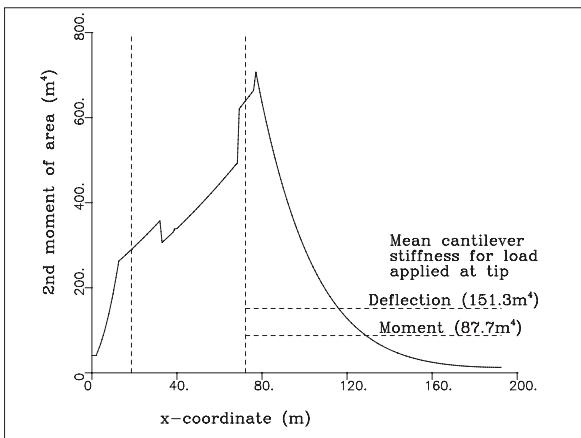
Fig 9.
Variation of second
moment of area in
one half-span

There is significant change in stiffness along the length of the bridge, and variation in centroid location, which can have a significant local effect due to shear lag as the stresses redistribute themselves on either side of a discontinuity. Step changes only occur at the support positions and in the back span, and these locations were not implicated in the failure.

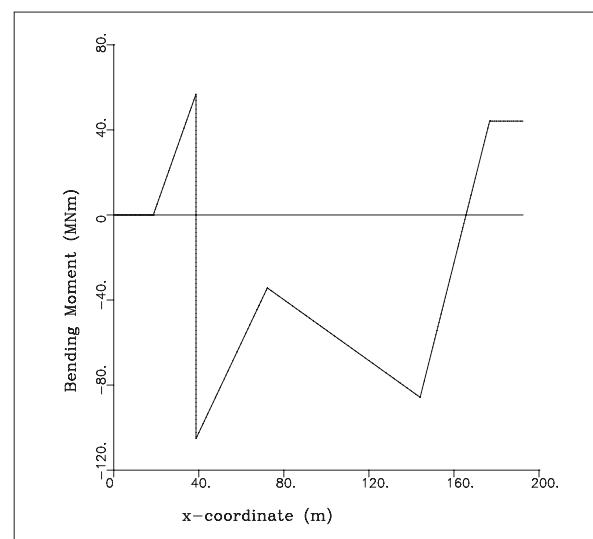
Fig 15. (right)
Bending moments induced in the continuous structure due to the continuity cables

Thus, it is concluded that the effect of these cables is limited to the bending moments shown in Fig 15, which have been obtained by analysing the bridge under the loads shown in Fig 14, assuming full continuity at the centre. At $x = 86\text{m}$ this gives a moment of 44MNm (sagging) and a shear force of 0.7MN. These are small by comparison with the values due to the beam's own dead weight.

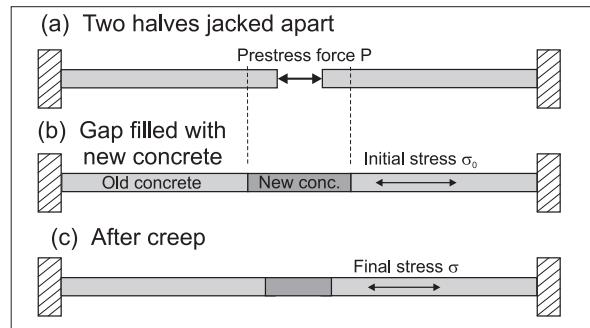
Fig 16. (above)
Forces due to flat
jacks at centre
Fig 17. (right)
Modelling effect of
flat jacks over time

An analysis has been carried out of a simplified problem, as shown in Fig 17, in which two pieces of concrete are forced apart axially and new concrete inserted. This was then analysed using the age-adjusted effective modulus method^{18,19}, and the variation of force with time plotted as shown in Fig 18.
