Cracking in clay – data report on cracking of clay beams by 4-point beam tests

N.I. Thusyanthan¹, S.P.G. Madabhushi², A.W. Take³ & M. D. Bolton⁴

CUED/D-SOILS/TR340 (2005)

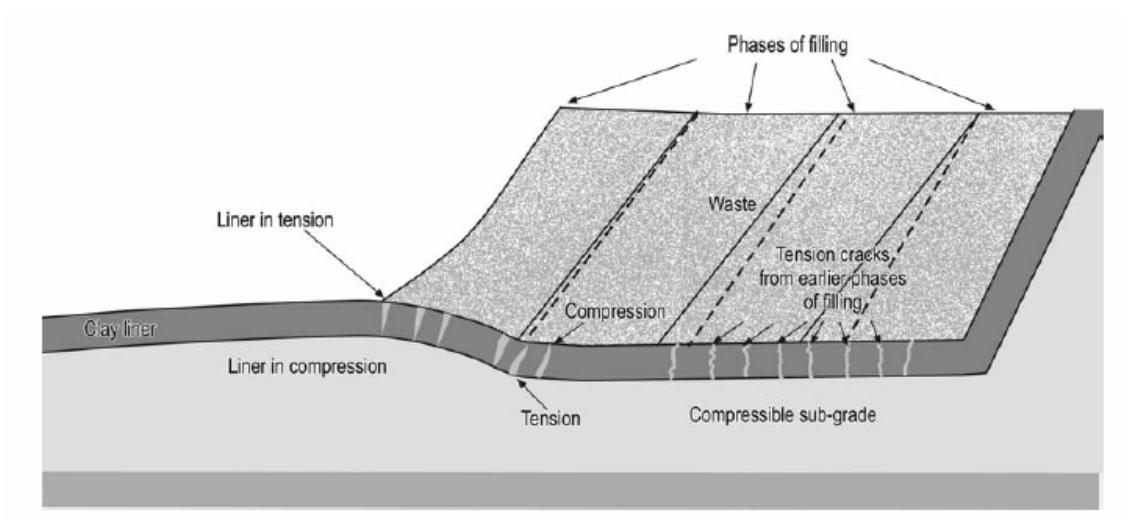
Fig. 1 Clay liner cracking (Environment Agency, R&D Technical Report P1-385/TR1Source).

Differential settlement of the landfill foundation can induce tension cracks in the clay liner. Fig. 1 shows such tension cracks in the clay liner in a schematic cross section of a landfill. These tension cracks can be difficult to observe in a landfill as they are below the waste fills and could cause leachate leakage and hence ground water pollution. Understanding the cracking phenomenon in clay is essential not only for landfill liners but also for other common facilities such as embankments and dams whose performs depend on the strength and permeability of clay. This chapter presents an investigation into the stress-strain criteria for cracking in clays by performing 4-point bending tests on consolidated kaolin clay beams (Thusyanthan et al. 2005e). The clay beams were obtained from specimens of kaolin clay one dimensionally normally consolidated to a stress of 500 kPa or 250 kPa. Load controlled and strain controlled tests were performed on clay beams with varying initial suction to understand the stress-strain criteria for crack initiation in clay. Tensile strain to cracking was measured by performing PIV analysis (White et al. 2003) on the digital images of the beams being subjected to bending, while the suction was measured by pore pressure and tension transducers (PPTTs) installed at three different locations within the beams.

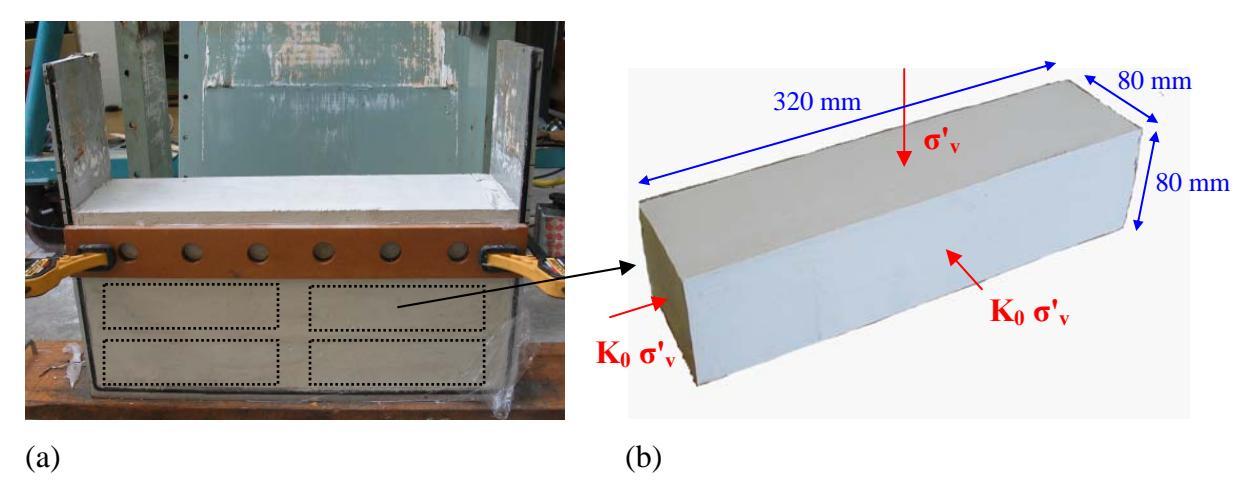
Fig. 2 Kaolin clay : (a) Consolidated clay specimen; (b) 320 mm × 80 mm × 80 mm clay beam.

E-grade kaolin clay powder was thoroughly mixed with an equal mass of water under vacuum to produce a slurry. The kaolin slurry at 100% water content was then one-dimensionally consolidated to an effective stress of 500 kPa or 250 kPa in a consolidation rig (Fig. 2(a)). Beams 320 mm long (transverse to the consolidation loading) and of 80 mm cross-section, weighing 4 kg, were cut from the consolidated clay specimens (Fig. 2(b)). All beams were wrapped in polythene and stored in air-tight containers prior to testing. The E-grade kaolin clay has a liquid limit of 51% a plastic limit of 30% and permeability of the order of 10⁻⁹ m/s (Barker, 1998). The values of critical state parameters of E-grade kaolin clay from various sources were summarised in section 3.5.2 in chapter 3- Thusyanthan 2005, Ph.D Thesis, University of Cambridge.

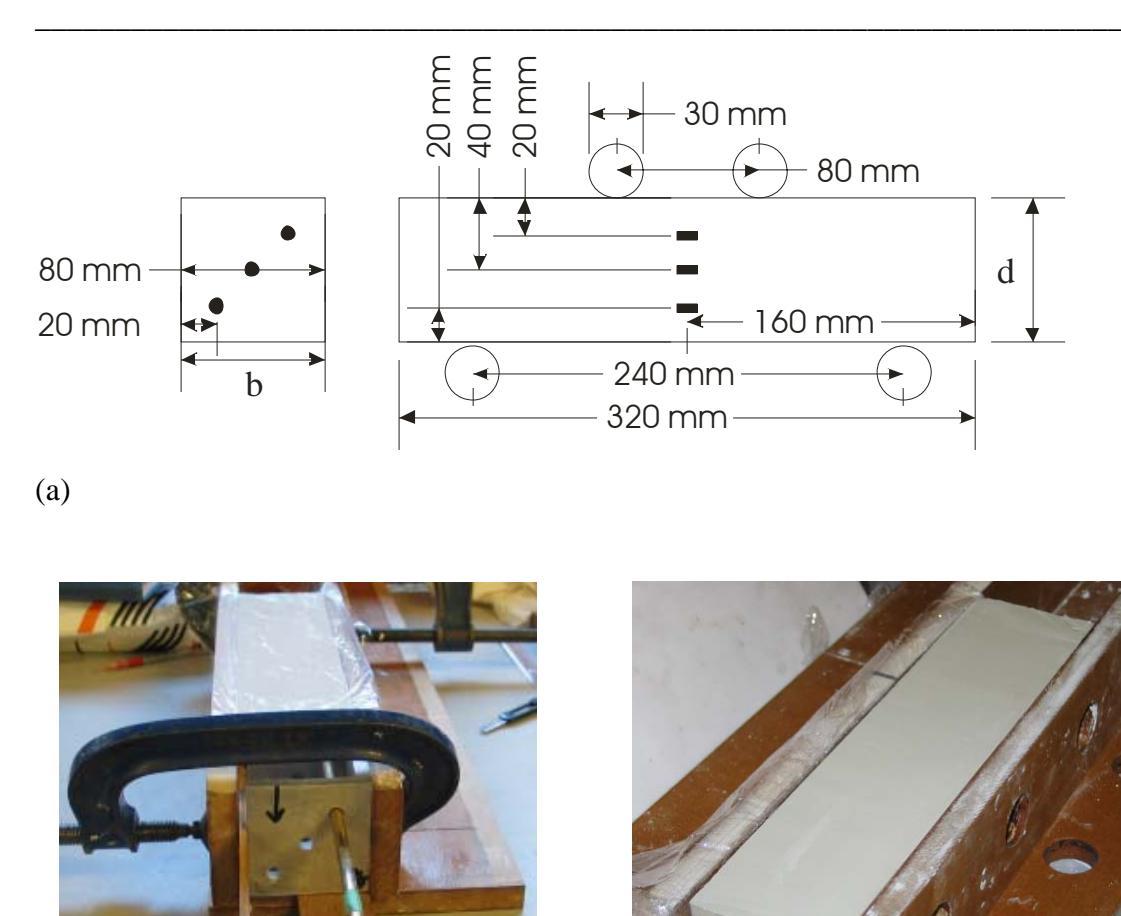
Fig. 3 Preparation of clay beams: (a) PPT location; (b) Drilling into clay beam; (c) PPTs installed and

Prior to testing a beam, it was removed from the air-tight container and three PPTTs (one near the compression face, one near the tension face and the other in the middle of the beam) were installed at the mid-length of the beam by slowly drilling from one end of the beam. The PPTTs were saturated under vacuum prior to installation. The details of the saturation process are described in Take and Bolton (2003). Fig. 3(a) shows the location of PPTTs in the clay beam. A wooden framework and an aluminium guide were used to ensure that the drilling alignment and depth were correct (Fig. 3(b)) with the beam protected against evaporation by a polythene cover. The PPTTs were installed on a diagonal of the cross section of the beam in an attempt to mitigate their tendency to weaken the cross-section. The PPTTs were inserted into the drilled holes, back filled with clay slurry and allowed to set (Fig. 3(c)). After the installation of PPTTs, the pore pressure was monitored to ensure that it was uniform before the polythene cover was removed. The elevation face of the beam which would face the digital camera was dusted with dyed fine sand. This gives the surface some texture which is required for good PIV analysis of the beam images.

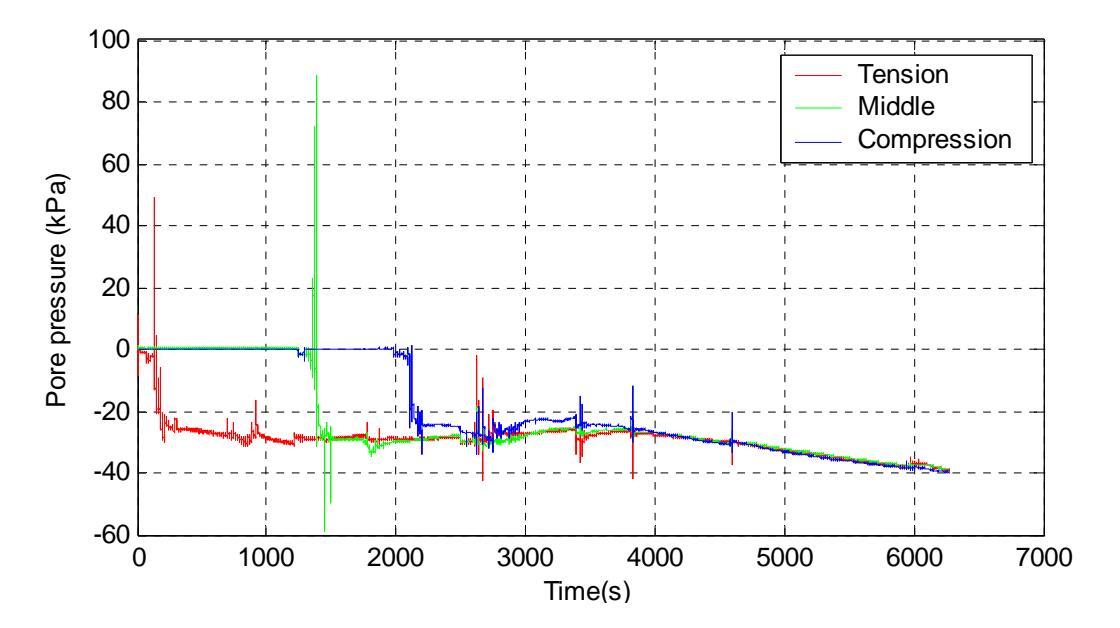
Fig. 4 PPT reading during and after installation of PPTTs into the clay beam.

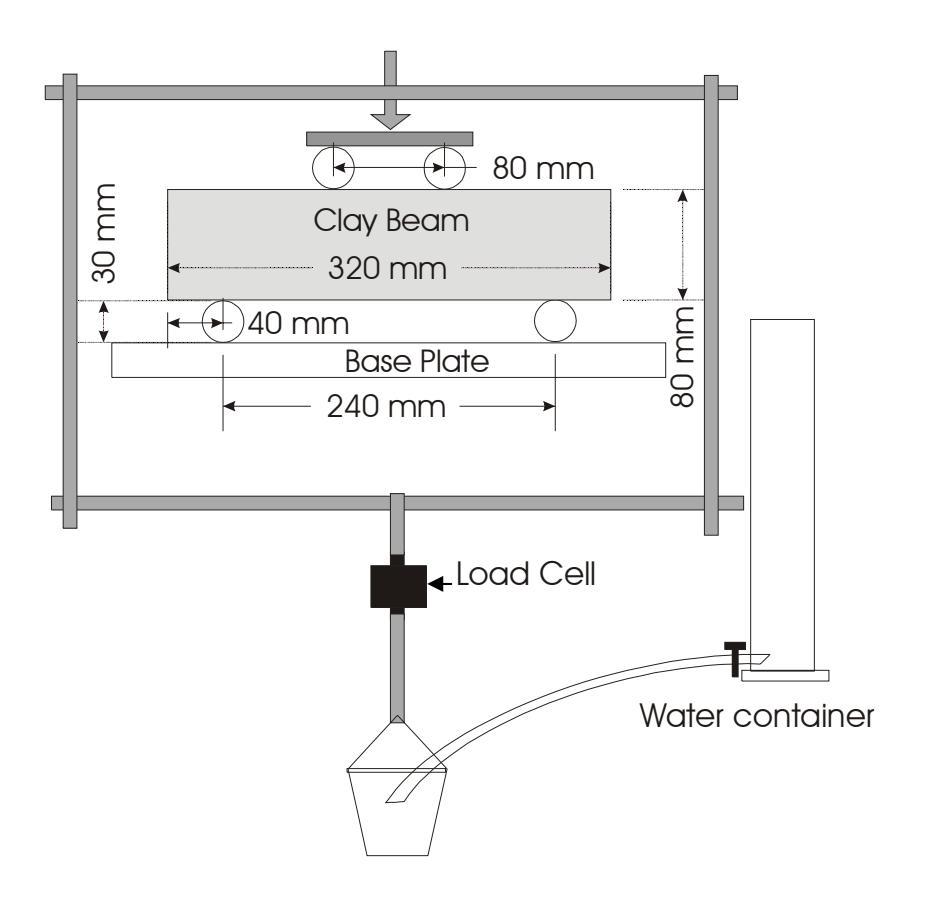
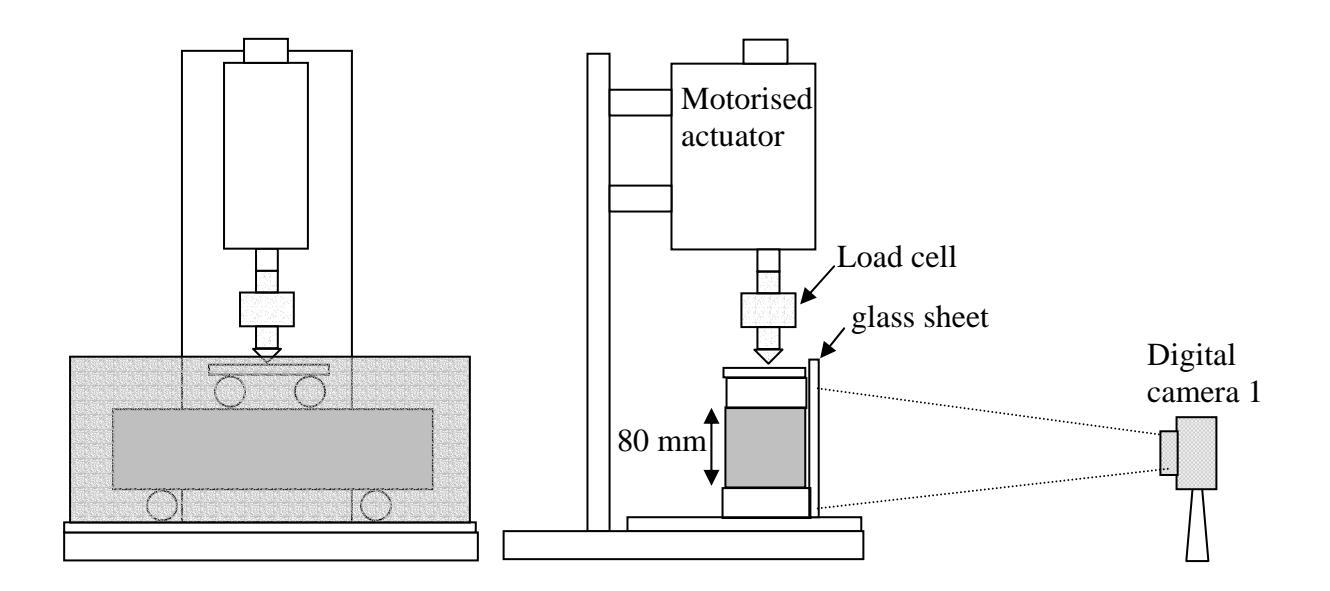
Fig. 5 (a) Setup for load controlled test; (b) setup for stain controlled test.

Load-controlled tests were carried out on 3 beams of type-A using the set up shown in Fig. 5(a). A step load of 20 N was applied to the beam at intervals of 180s by allowing 2 kg of water to flow into the bucket attached to the framework. Fig. 5(b) shows the set-up used in strain-controlled tests. A motorised actuator was used to apply the load on the beam at a uniform displacement rate of 0.23 mm/min. Pore pressure readings from all 3 PPTTs were recorded throughout the tests.

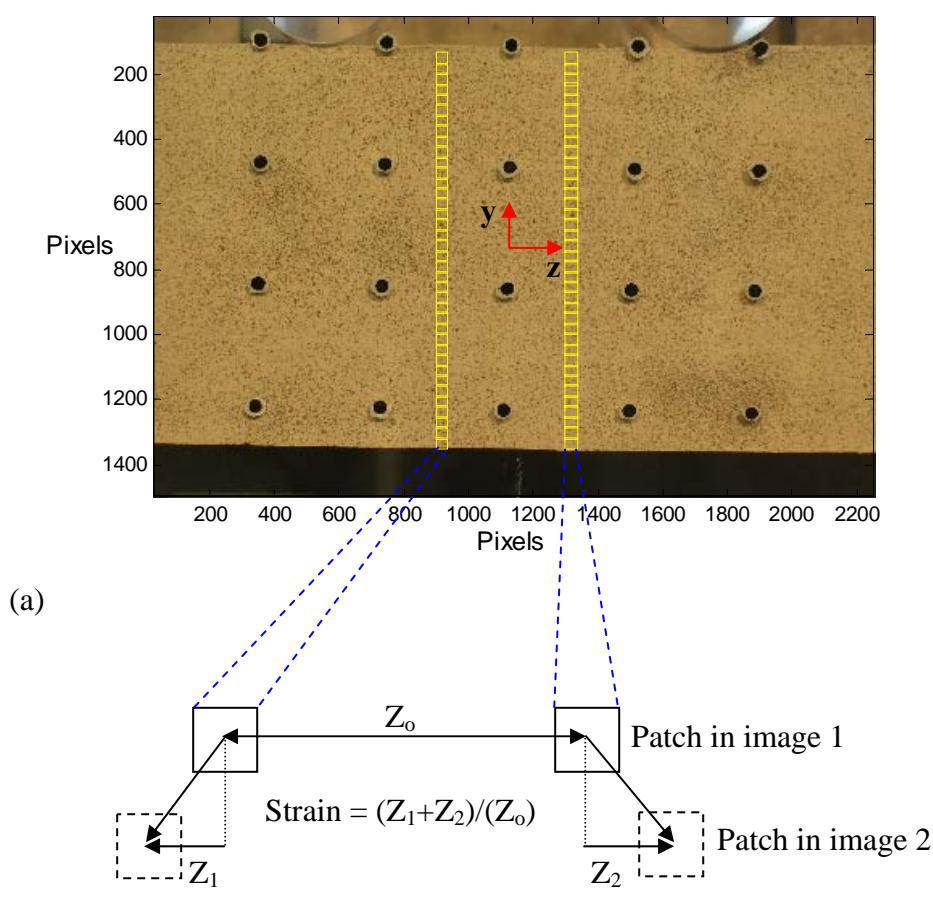
Fig. 6 (a) View from camera 1 and 32×32 pixel size patches used in PIV analysis; (b) strain calculation from the patch movement

As PIV operates on image texture rather than pre-defined target markers, the displacement of any location throughout the beam could be measured. In this application, 33 pairs of 32x32 pixel measurement patches were defined in the digital image on either side of the mid-span of the beam throughout the full height (Fig. 6(a)). Thus, these pairs of displacement nodes can be thought of as thirty-three virtual strain gauges and can be used to calculate the longitudinal strains throughout the depth of the beam by dividing the horizontal movement of the two patches making up each pair by the original distance between the patches (Fig. 6(b)).

Digital images of the beams were captured every 10s during flexural testing by two 4 Megapixel digital cameras: one focussed on a wide field of view to observe the behaviour of the entire beam (Fig. 7)and the other zoomed to capture the detailed behaviour of the mid-span (Fig. 6(a)). As shown in Fig. 6(a), a thin glass sheet containing a grid of black control makers at known locations was placed in front of the beam to provide a reference coordinate system visible in both cameras. This coordinate system was then used to improve the precision of the measured strains using photogrammetric camera calibration to remove camera errors such as the variation in scale factor due to imperfect camera positioning, radial and tangential lens distortion, and refraction (White et al., 2003).

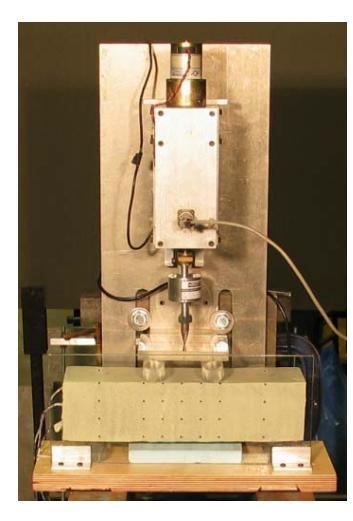
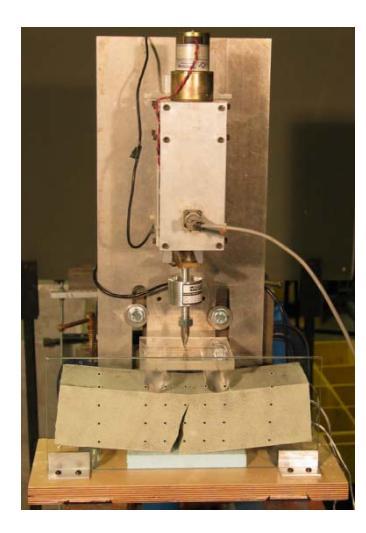
Fig. 7 Images from camera 2
